**ADDIS ABABA UNIVERSITY  
SCHOOL OF GRADUATE STUDIES  
COLLEGE OF DEVELOPMENT STUDIES**

**PROBLEM ASSESSMENT IN DURAME TOWN WATER  
SUPPLY**

**A Thesis Submitted in Partial Fulfillment of the  
Requirement for  
Degree of Master of Art in Environment and Development**

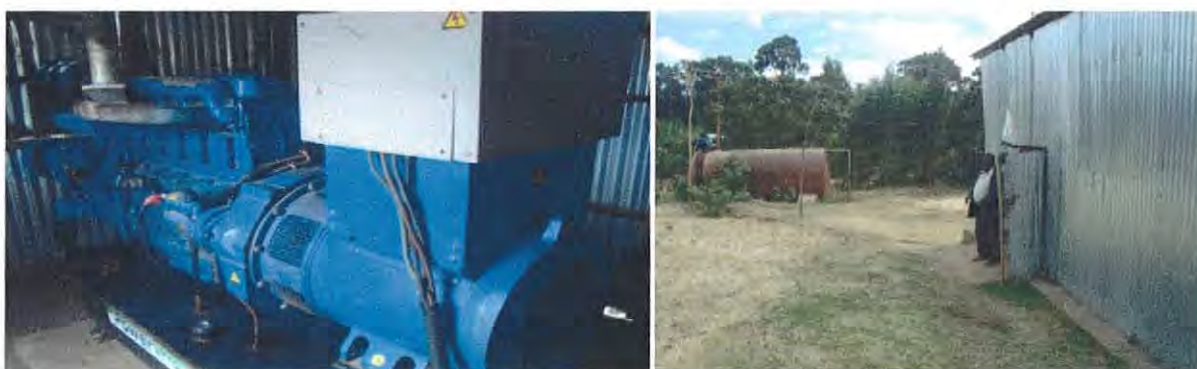
The borehole operates 19 hours a day producing an average of 296m<sup>3</sup> of water considering reported yield of 4.3l/s, that is pumping to booster station and then to 150 m<sup>3</sup> concert reservoir.

Figure 2: Generator at Gocho Bore hole

The supply from borehole is boosted on its way to the main reservoir. In the middle there is a booster station with vertically installed submersible pump and 30m<sup>3</sup> steel wet well. This pump transfers water to the main reservoir. It is observed that a low level electrode is installed in the steel tank to avoid dry running of the pump, and to make the system functional.

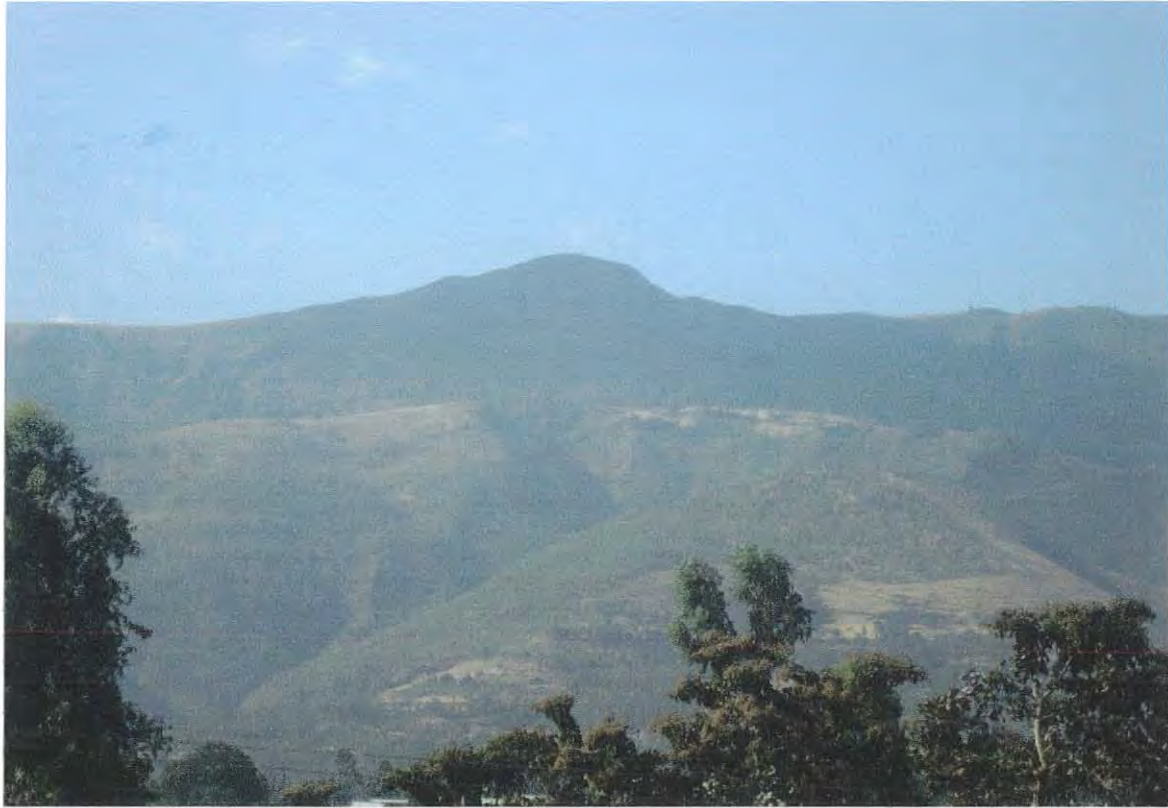
Figure 3: The Ambericho mountain where spring sources exist

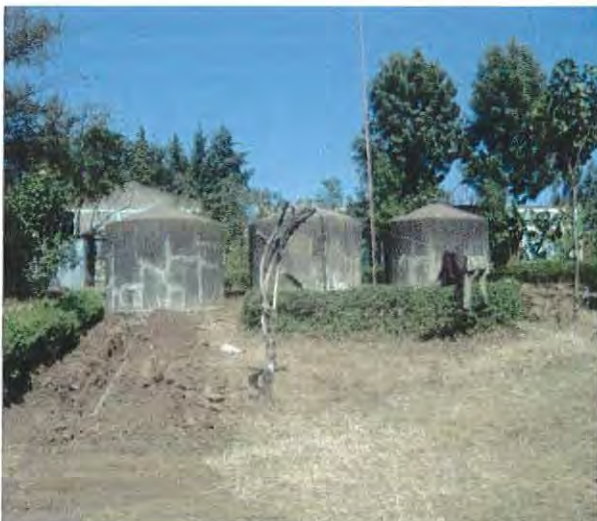
Figure 4:Gogota care reservoir

The Gogota Care reservoirs and the surrounding area in which these are expected to feed were located at relatively the same elevation; in effect distributing water from these reservoirs by using gravity has not been effective so far.

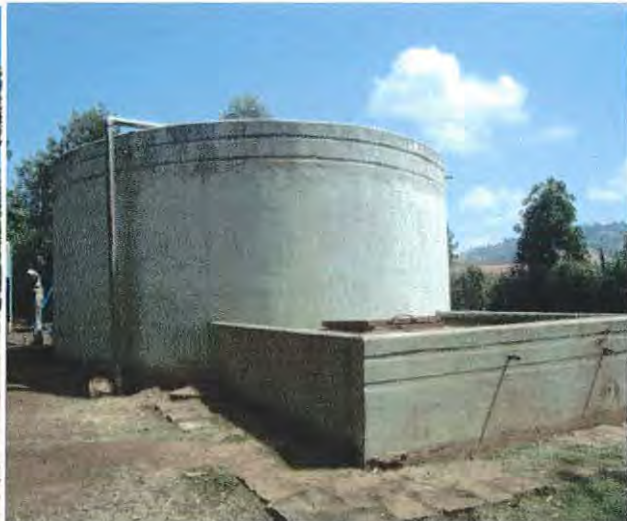
KMG Reservoir

In replacement to these KMG reservoir was constructed to cover the demand for the newly expansion area and the Gogota surrounding. At this point there is a bulk water meter but it is not functioning. The relative position of the reservoir as compared to the town setting is good and large area can be covered from this reservoir. But according to the key informant interviewee from zonal water resource office the area at leliso(05 kebele) and the surrounding can't get water from both reservoirs. Therefore, creating third zone at an elevation of 2175m and adjacent to Kalehiwot church by constructing new reservoir will solve the storage and distribution problem.

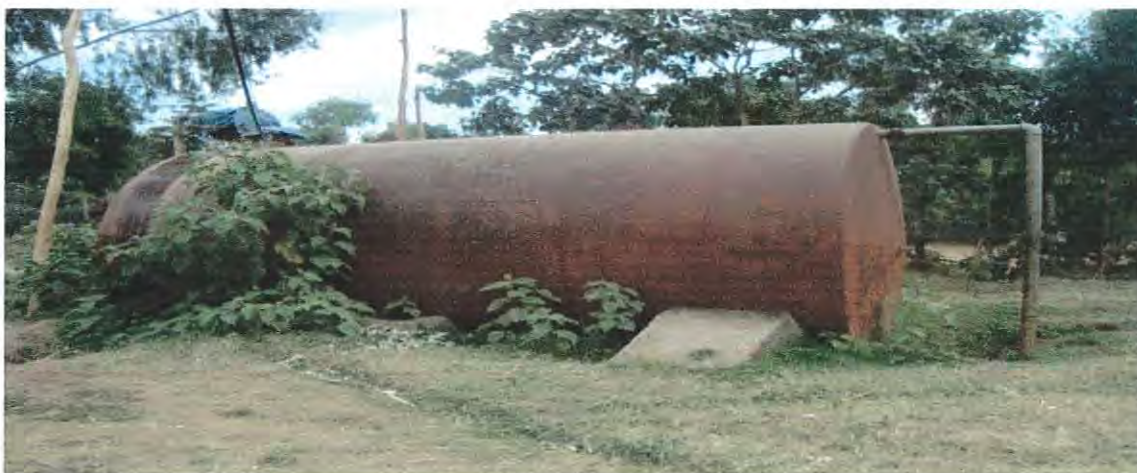
The other potential source of pollutant for the town water is the steel wet well at booster station which is claimed to be to contaminate the system due to rusting. The KII w/o Meselech Taddese from DWSSO said, due to vertically installed pump inside steel wet well, cleaning the wet well regularly has been difficult for long time.

Figure 5: The steel wet well at booster station

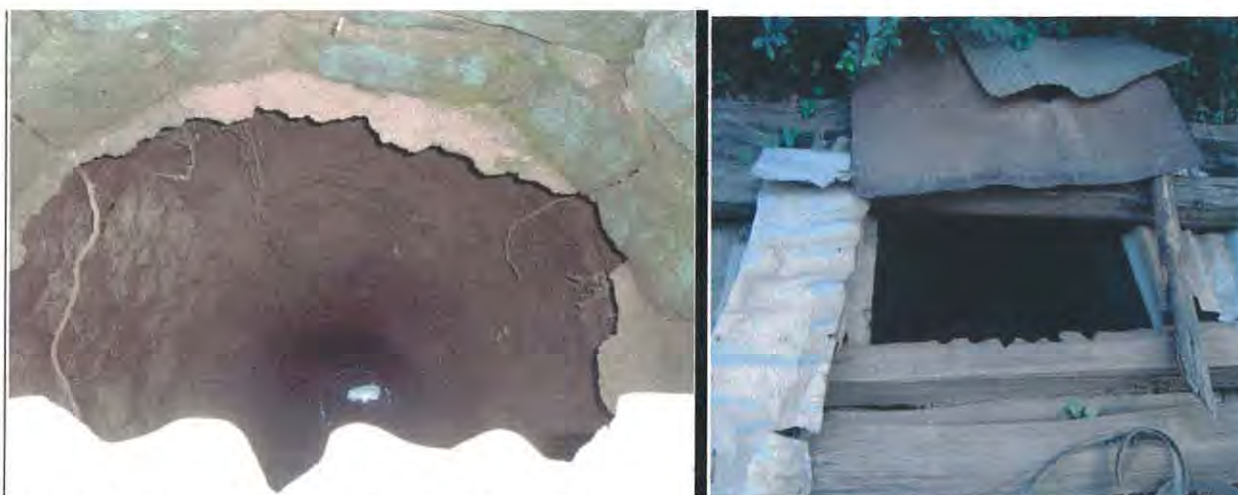
Some percentages of the population also collect water from unprotected source such as dug well and unprotected spring. As per the observation of the researcher these wells are not constructed properly, no head work at the top of the well, no concrete ring inside the well and no manhole cover constructed. Consequently, dirt, debris, runoff, etc. infiltrate to the well and contaminate the water. In addition people and animals fall in easily and loose their life. No quality test was undertaken whether to use it for drinking purpose or not. In general dwellers that are using these sources are liable to water born and related disease.

Figure 6: Hand dug well with no proper construction at lalo kebele

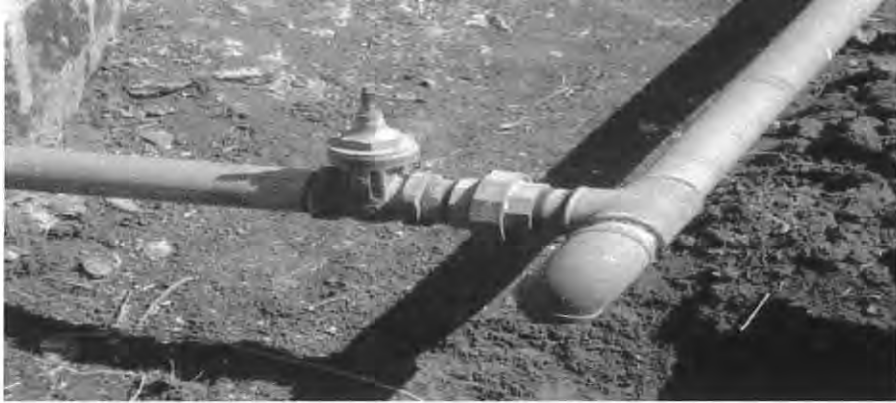
Once the town water distribution system was constructed there were no major expansion works that were executed. But the focus group discussion with DWSSO revealed that even though there were no major expansion works undertaken, minor expansion works at the request of the beneficiary was in effect by WSSO. In reality, decision to expand the existing system should be made by calculating the existing water production and comparing with consumption. If the existing production is greater than and in sufficient quantity to supply the demand, decision would be made to expand the existing system. Otherwise simply elongation of the pipe at the request of the customer is a futile exercise which ultimately leads most of the pipe to run dry. This is what the researcher observed during survey time at lalo kebele and industrial college where there is no water in the pipe at all time.

Figure 9: Pipe line at industrial college with no water at all
